**Progress Report Item No. 0001A**

**Award No. N00014-12-M-0147**

**Reporting Period: April 15, 2012 to September 27, 2012**

# **Gear Fatigue Diagnostics and Prognostics Progress Report**

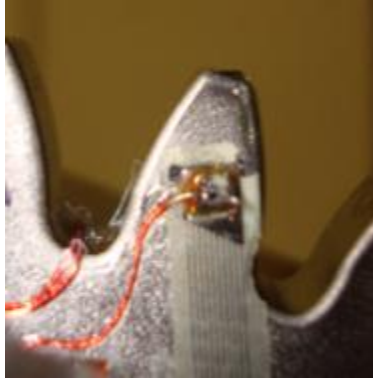
Fig. 5. A gear tooth equipped with crack propagation sensors after crack initiation.

After a crack is initiated, the cracked tooth is instrumented with two crack propagation sensors, as shown in Fig. 5.

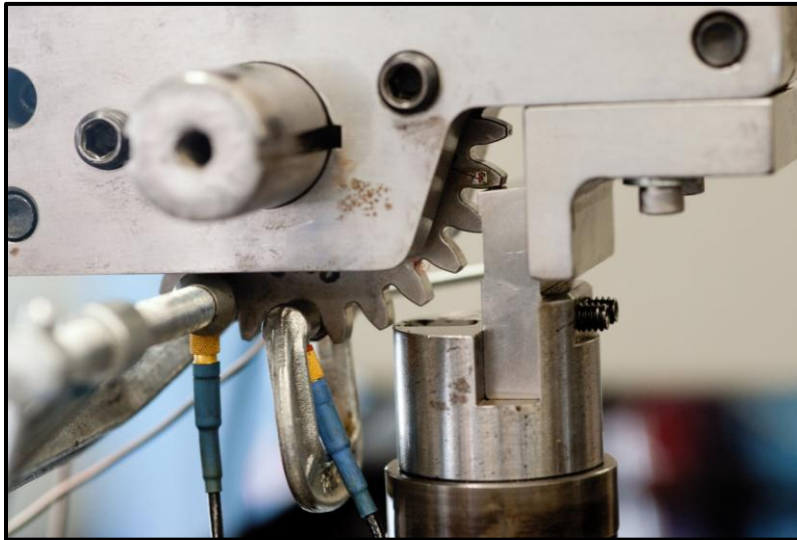
Fig. 8. Close-up of AE instrumentation of the single-tooth fatigue fixture. This image is credited to Dr. Adrian Hood of ARL.

Acoustic emission (AE) was collected during single-tooth testing, i.e. crack initiation and propagation on the fatigue tester, and during crack propagation on the gearbox testing. The AE sensor placement on the single-tooth fatigue fixture is shown in Fig. 8.
